Materials Report, 77-A

FATIGUE CRACK INITIATION PROPERTIES OF WELDED  
AND STRESS RELIEVED HY 130 STEEL

I. P. Nikiforuk B. F. Peters

December 1977

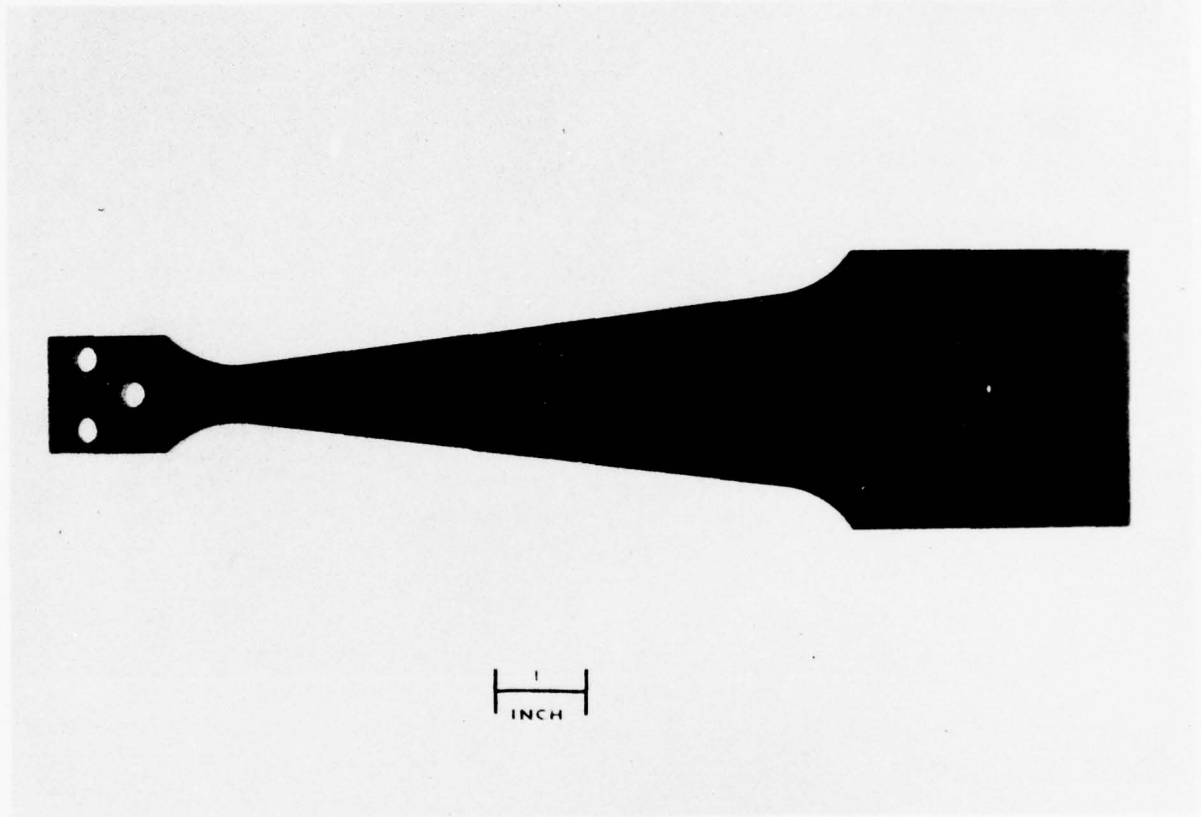
FIGURE 1: 6.4 mm(.25 in) thick HY130 plate fatigue specimen with E12018 stick weldment (for Series 4a to 4e)

- 1) Parent material, fine ground and polished,  $R = -1$ 
  - (a) from "as received" material
  - (b) from "stress relieved" material
- 2) Mill-finished parent material (ground on one side),  $R = -1$ 
  - (a) from "as received" material
  - (b) from "stress relieved" material
- 3) HY130 welded with MIL-140S wire, fine ground and polished,  $R = -1$ 
  - (a) from "as welded" material, with weld running across the specimen
  - (b) from "stress relieved" material, as above
- 4) Mill-finished material welded with E12018 rod, and the weld bead left proud,  $R = -1$ ,  $R = 0$ , and  $R = \frac{1}{2}$ .
  - (a) from "as welded" material with weld running across the specimen as in Figure 1.
  - (b) from "stress relieved" material, as above.

The flat specimens were all similar in shape to that shown in Figure 1. Specimens for Series 1 to 3 were all cut from 12.7 mm (0.5 in.) plate and ground to final dimensions approximately 3.2 mm (0.125 in.) thick. Prior to testing, all the ground surfaces were hand polished longitudinally to ensure that small stress raisers were removed.

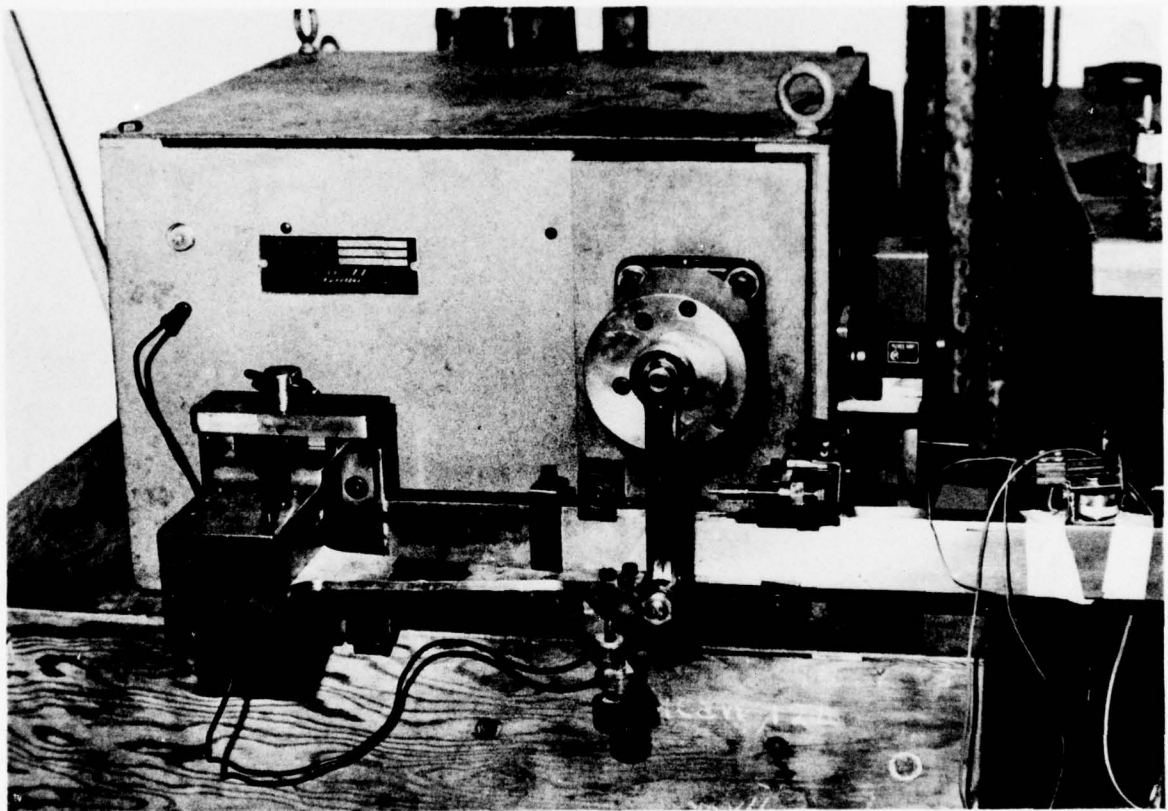
FIGURE 2: Fatigue specimen in DREP Tatnal-Krause type fatigue machine.

The fatigue specimens were cycled in a Tatnal-Krause type fatigue testing machine (Figure 2) at a cyclic speed of approximately 1200 CPM. Normally, specimens were cycled to failure or to  $10^7$  cycles.

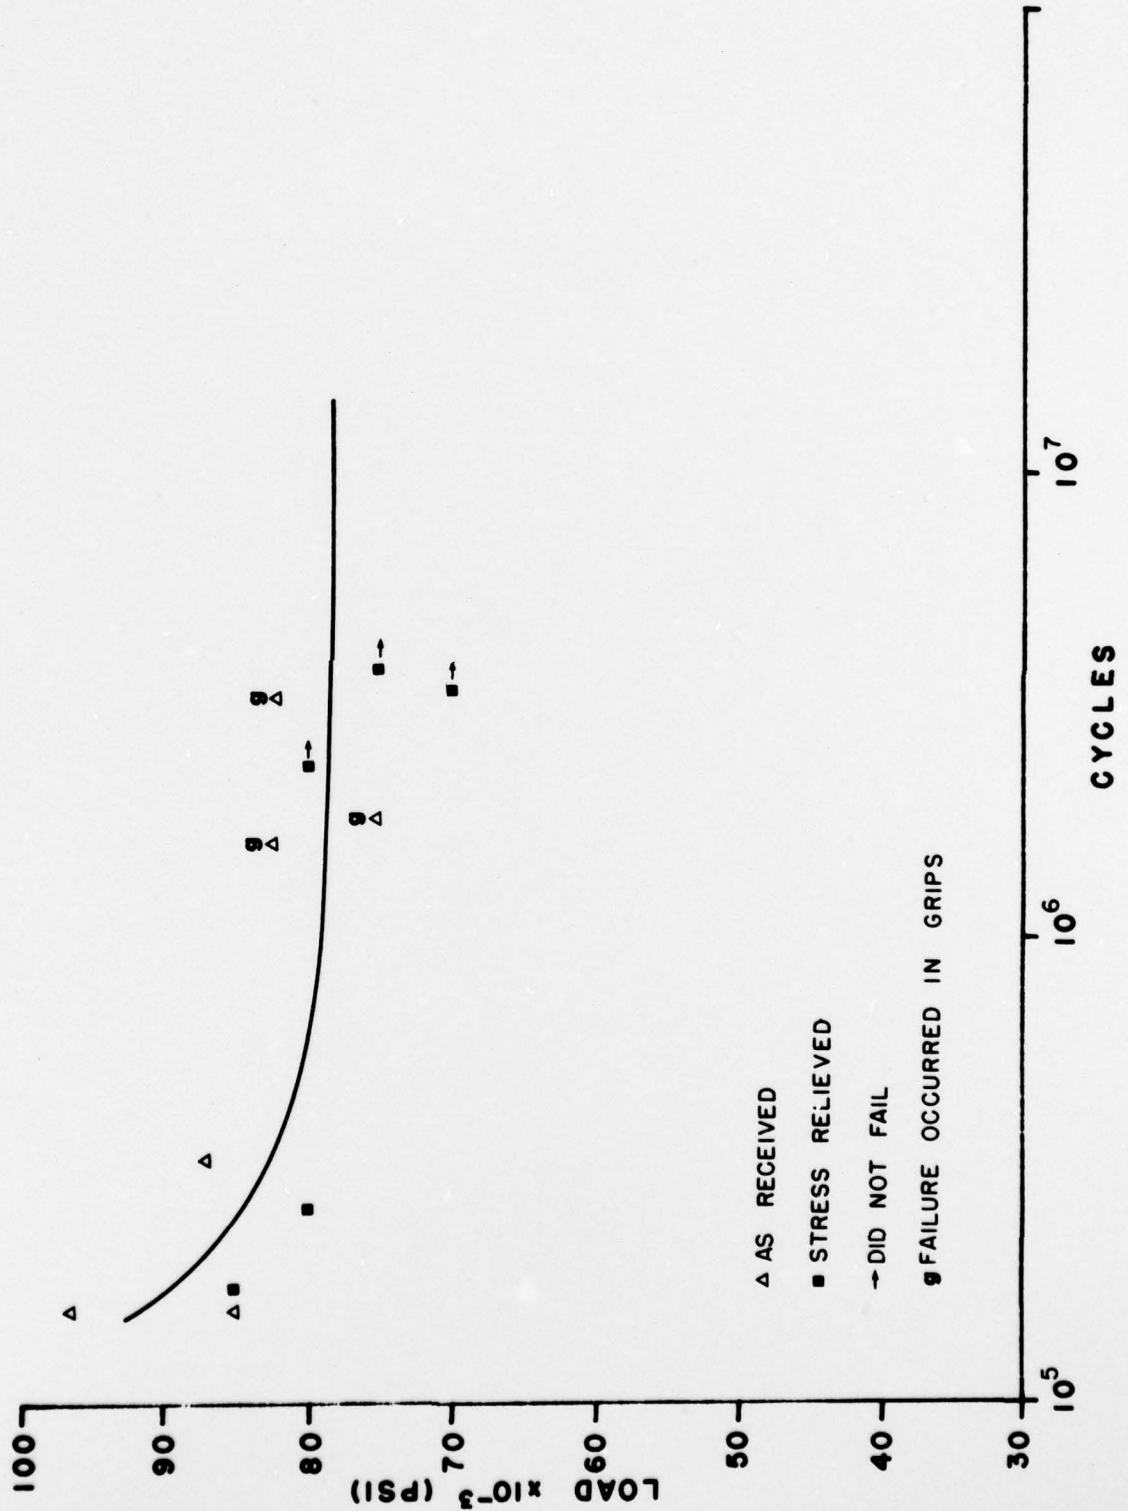
FIGURE 3: S-N Curve for AMVD HY130 plate. Machined and ground (Series 1a and 1b).

The Series 1 specimens indicated (Figure 3) that HY130 had, in the machined and ground condition, an R = -1 endurance limit of approximately 515-550 MPa (75-80 Ksi). It would appear that the stress-relief heat treatment had no significant effect on the fatigue properties of the parent plate.

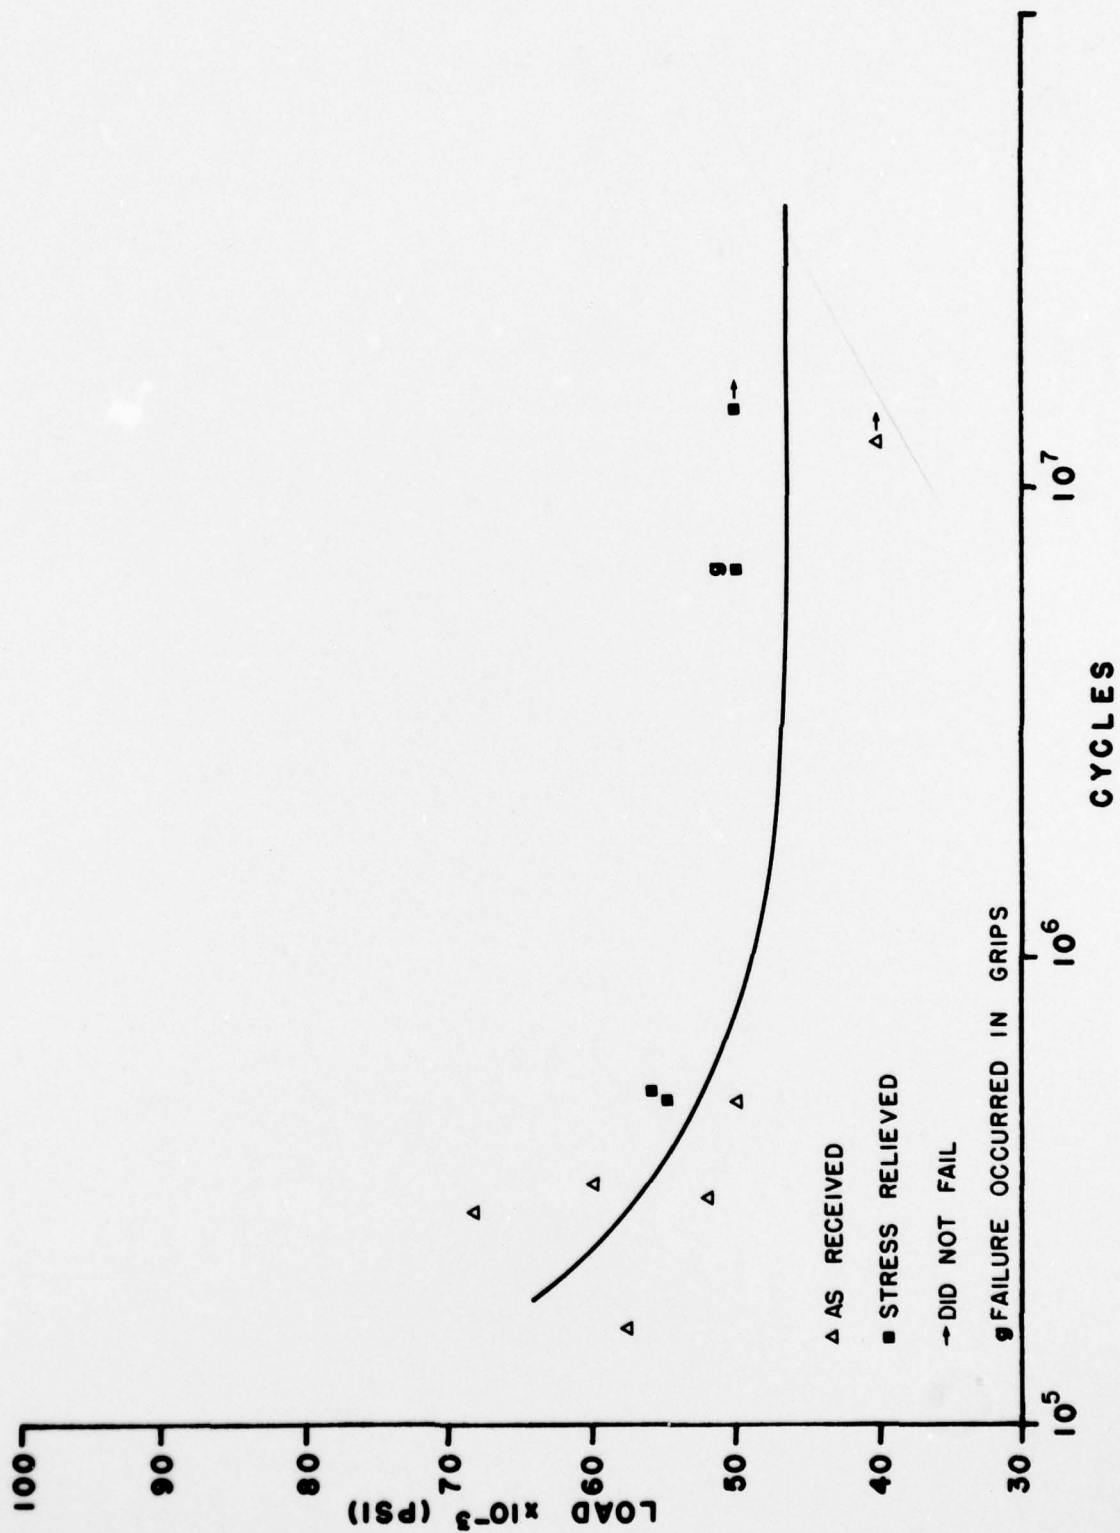
FIGURE 4: S-N Curve for AMVD HY130 plate "as-rolled" (mill finish, Series 2a and 2b).

The mill-finished plate, with its rough "pebbled" surface, Series 2 and Figure 4, had a much lower endurance limit; that is, approximately 310 MPa (45 Ksi) at  $R = -1$ . Here again, the stress relief heat treatment had no significant effect. It was observed, with these specimens, that more than one crack would initiate on the rough mill-finished plate, as shown in Figure 7.

Based on the limited data, the unwelded mill-finished material (Series 2, Figure 4) showed no significant change in fatigue properties when stress<sup>10,11</sup> relieved. It is known that the mill-finished material has large surface compressive residual stresses, stresses that should improve the endurance limit of the material. However, the stress relief which removed these stresses did not lower the endurance limit of the material, indicating that the surface roughness effect is the more dominant factor.

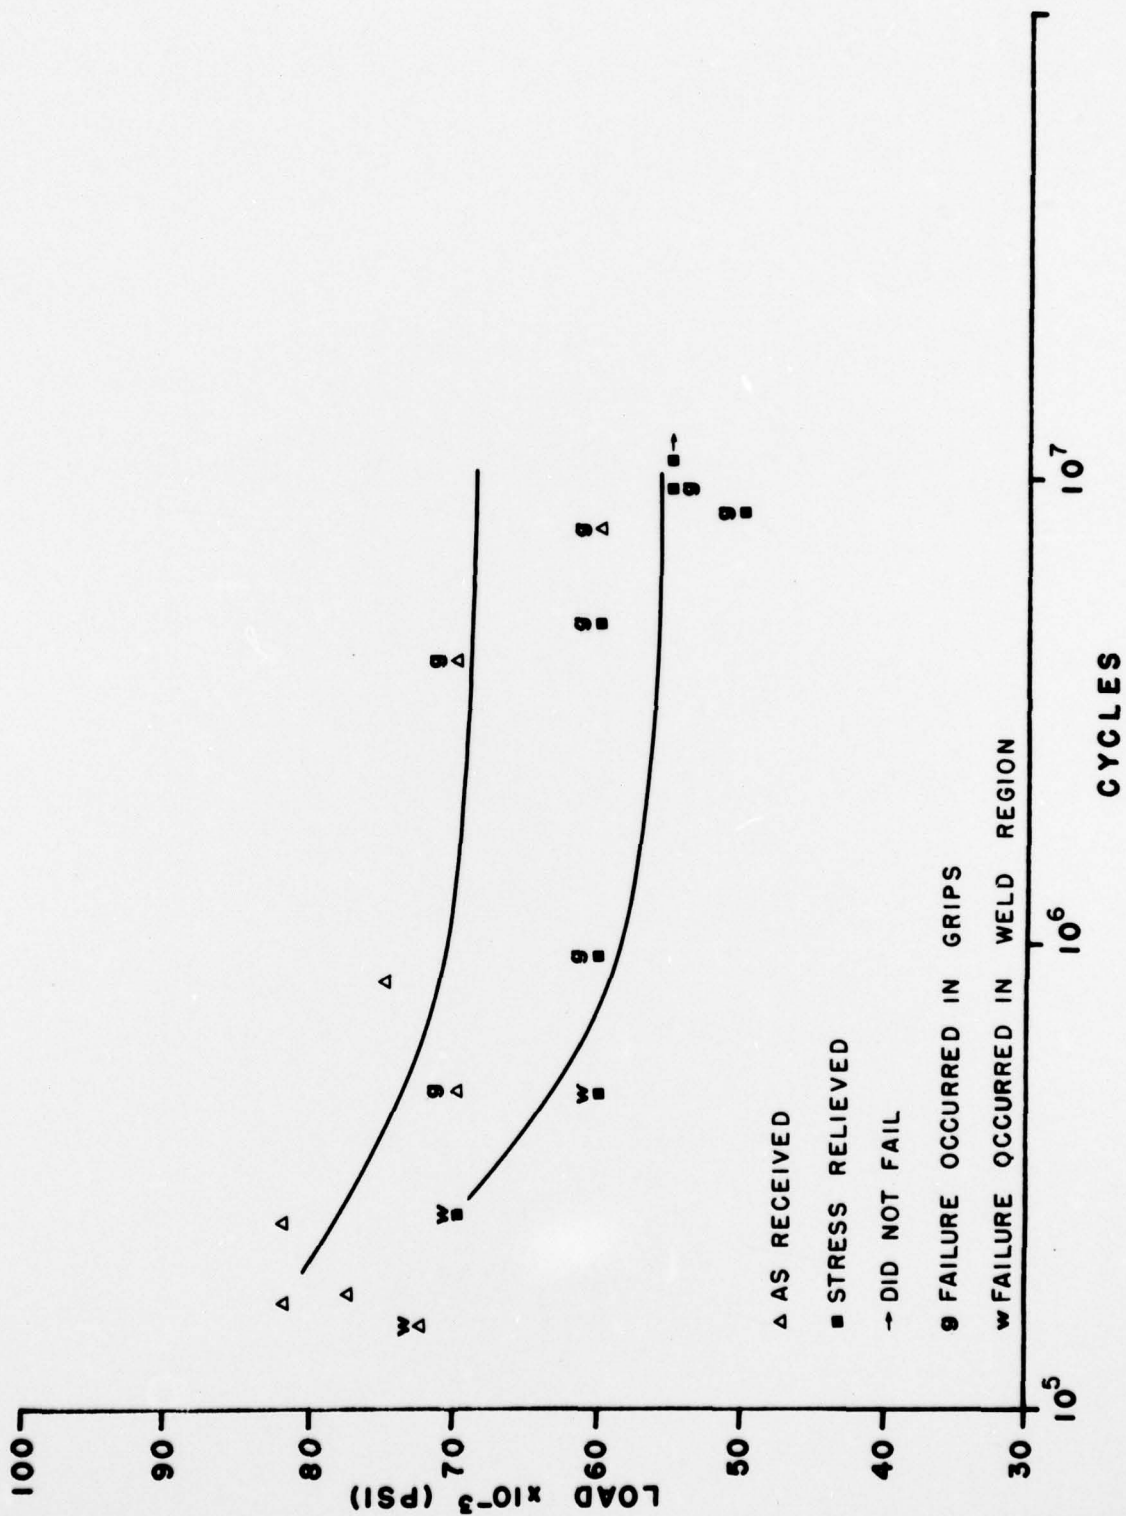
FIGURE 5: S-N Curve for AMVD HY130 plate, 140 Mig welded. Ground and polished. (Series 3a and 3b)

The welded (MIG) ground and polished specimens, Series 3(a) and Figure 5, showed an endurance limit at  $R = -1$  of approximately 480 MPa (70 Ksi). It is noteworthy that all but one of these specimens failed in the same place in the parent plate, well away from the weld and heat affected zone. The stress relieved specimens tended to fail in the weld and the endurance limit appears to have been reduced to approximately 415 MPa (60 Ksi) by the heat treatment. The tendency for the as-welded specimens to fail outside the weld zone (region of highest residual stress) was quite distinct.

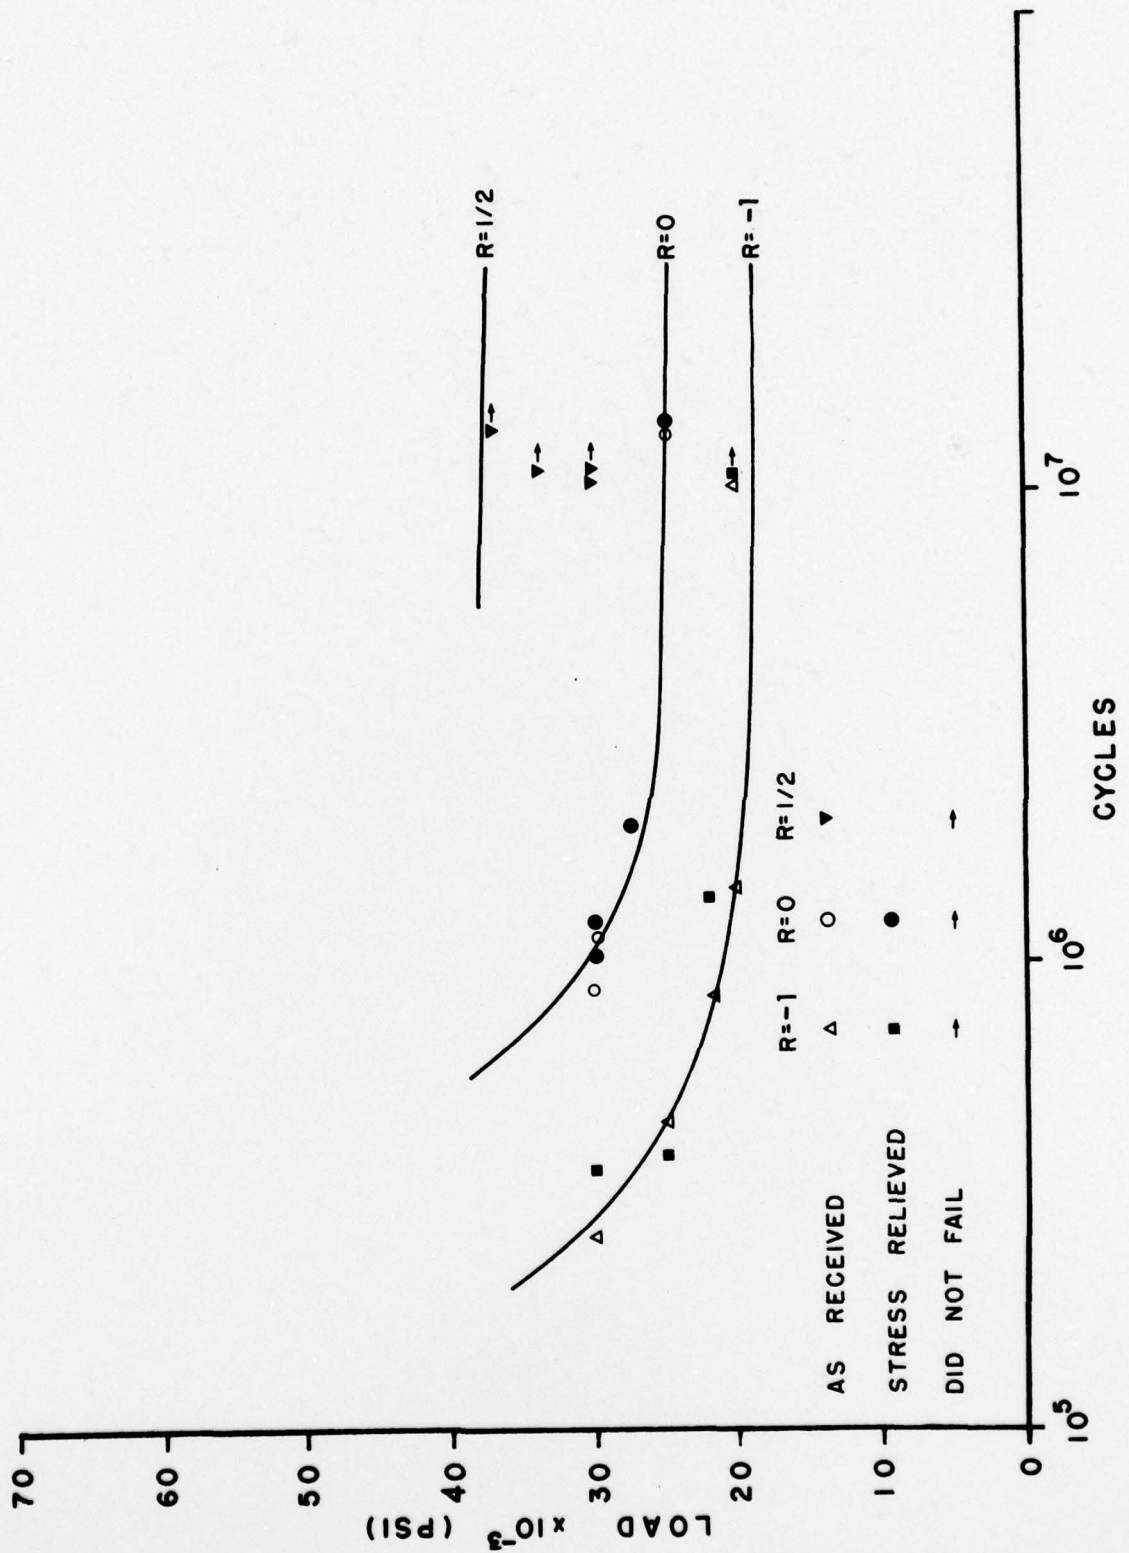
FIGURE 6: S-N Curve for (6.4 mm) AMVD HY130 plate, E12018 welded, "as-welded" (Series 4a to 4e)

The welded (E12018) 6.4 mm (0.25 in.) specimens, Series 4 and Figure 6, showed similar fatigue properties in the as-welded and stress relieved conditions when tested at all R values. The fatigue endurance limit varied with R values: 140 MPa (20 Ksi) at  $R = -1$ , 170 MPa (25 Ksi) at  $R = 0$ , and 240 MPa (35 Ksi) at  $R = \frac{1}{2}$ . Failure in all cases occurred at the notch formed by the weld bead and the parent plate, as shown in Figures 10 and 11.

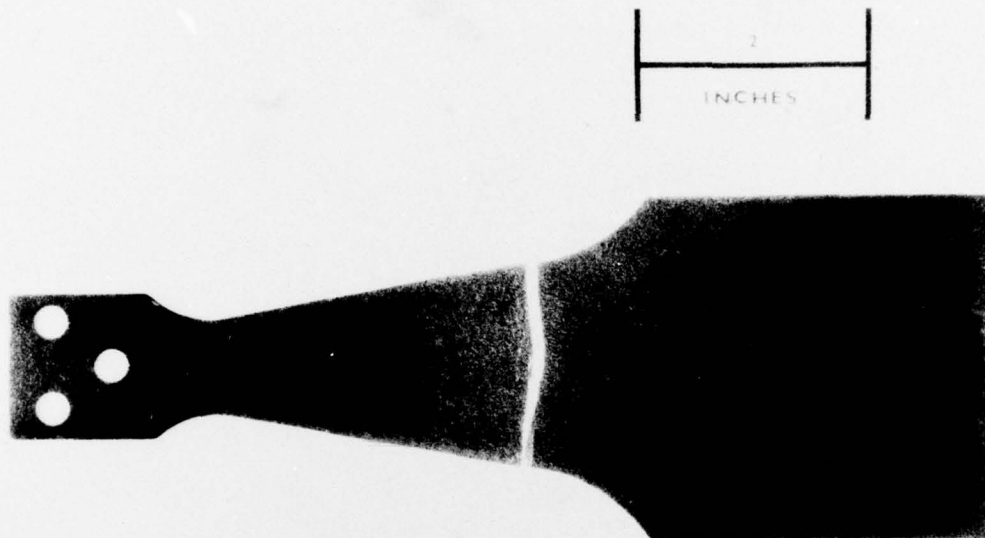
FIGURE 7: Mill finished fatigue specimen, from Series 2a and 2b, showing more than one crack initiating.

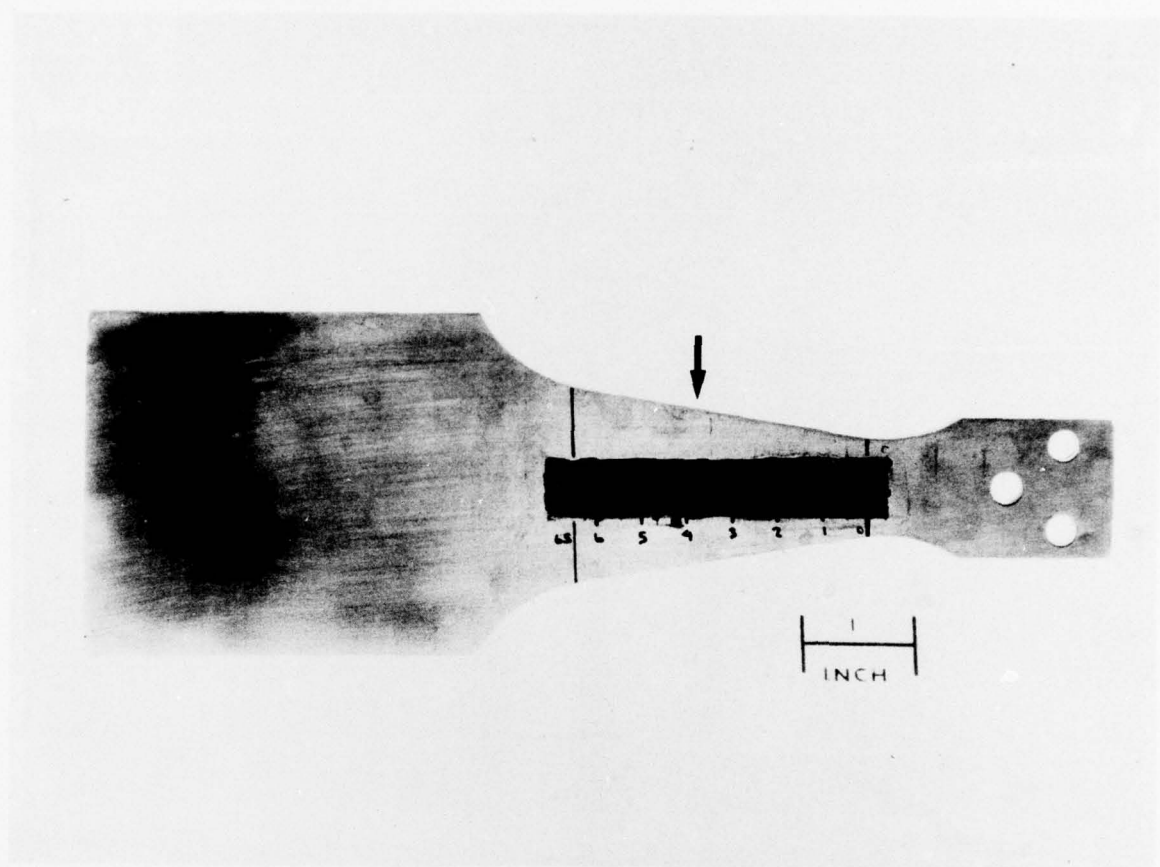
FIGURE 8: Mig-welded specimen from Series 3a, electropolished to evaluate residual stresses (see TABLE IIIA). The arrow marks the weld.

One of the fatigue specimens from Series 3(a) was analyzed for residual stresses at the University of B.C., using x-ray diffraction techniques. The results for the specimen shown in Figure 8 before and after fatigue testing at a stress of 415 MPa (60 Ksi) for  $7.6 \times 10^6$  cycles, are outlined in Table IIIA. These specimens had been ground to 3.2 mm thick with the result that the residual stresses were significantly reduced from the as-welded plate. DREP residual stress results based on strain gauge work on as-welded E12018 weldments<sup>12</sup> are summarized in Table IIIB.

The residual stress study on the electropolished specimen (Figure 8) stressed at 415 MPa (60 Ksi) for  $7.6 \times 10^6$  cycles, indicated that fatiguing did not result in a stress relief. This is consistent with the results of others<sup>9</sup> for specimens evaluated at stresses near the fatigue limit.

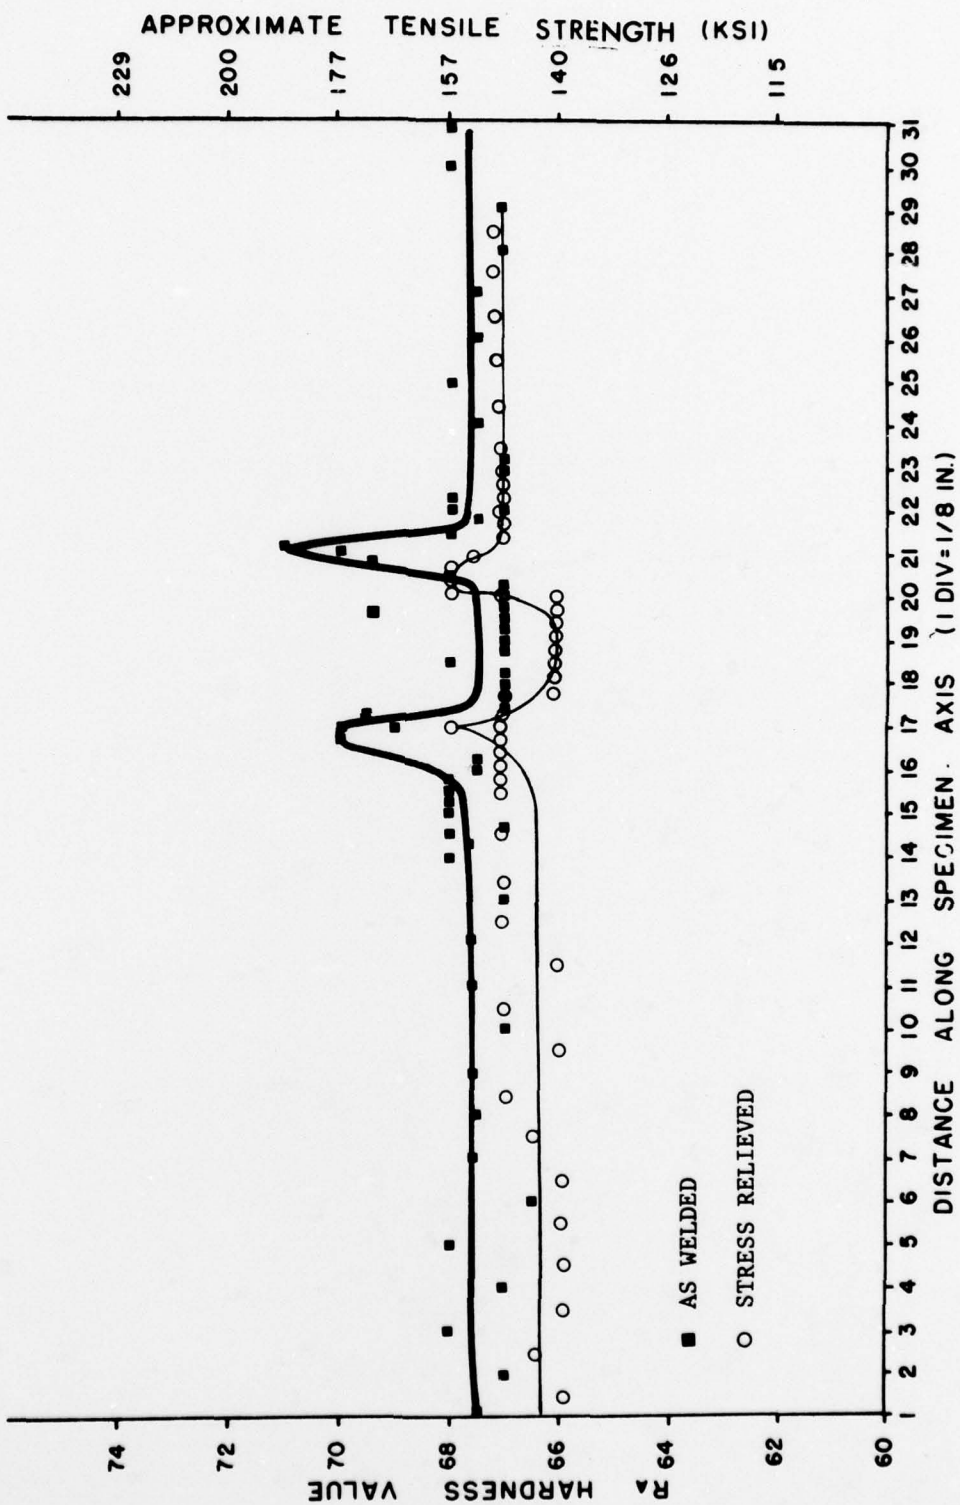
FIGURE 9: Hardness scan across Mig welded HY130 fatigue specimen from Series 3, before and after stress relief heat treatment.

The hardnesses of the fatigue specimens were also evaluated before and after stress relief heat treatment, as shown in Figure 9. Hardness tests indicated that the heat affected zone was significantly stronger than the parent plate and weld. Stress relief heat treatment lowered the overall hardness of the specimen but the HAZ remained stronger.

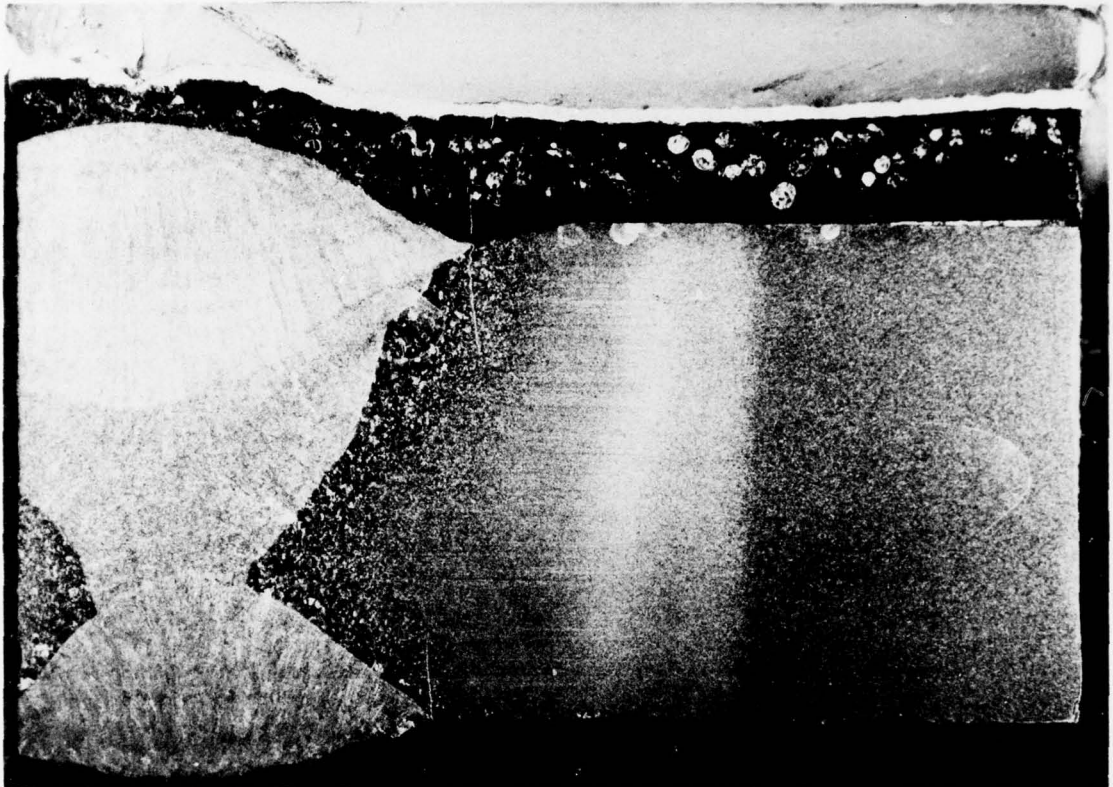
FIGURE 10: Section through HY130, E12018 welded, fatigue specimen from series 4, showing cracks initiating at edge of weld bead. (10x)

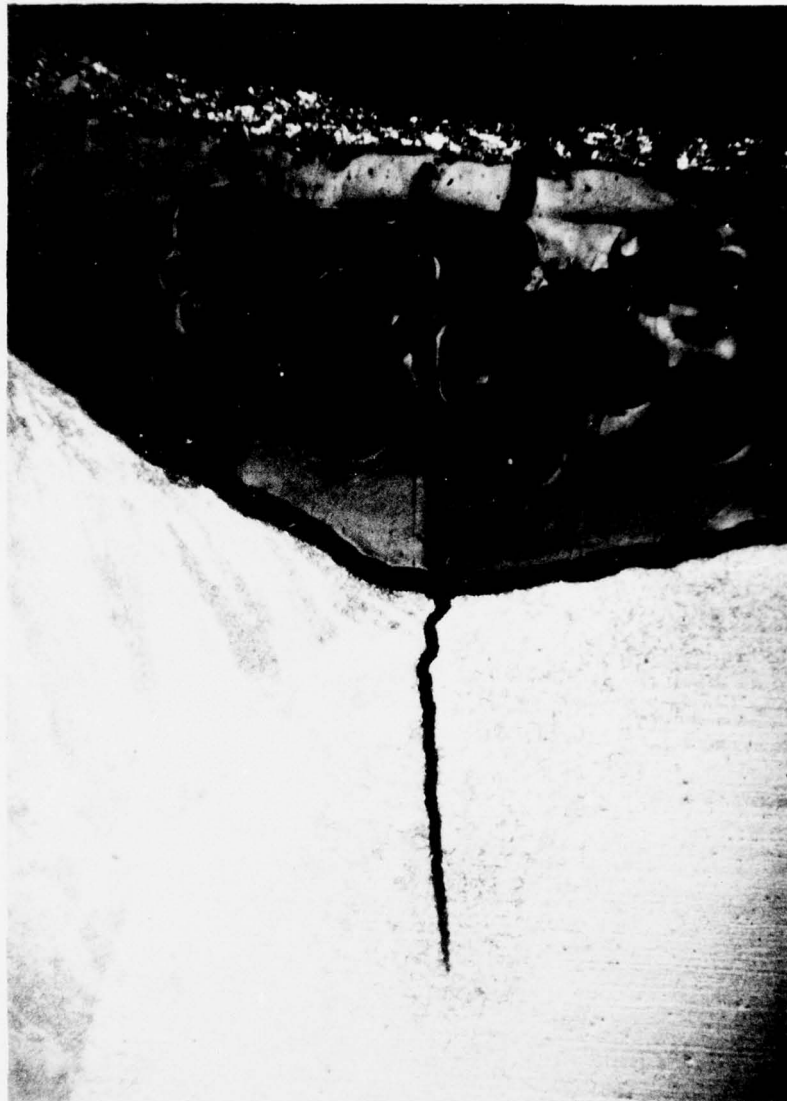
FIGURE 11: Fatigue crack in HY130, E12018 welded, fatigue specimen (Series 4).

Considering the Series 4 fatigue specimens, where comparisons could be made for the heat affected structure (Figure 11), no differences were noted between material in the as-welded and stress relieved conditions. However, there were distinct differences between specimens that had been stressed under  $R = -1$  and  $R = 0$  conditions: those stressed in straight tension ( $R = 0$ ) showed very distinct striations, as in Figure 14, compared to those tested under both tension and compression conditions ( $R = -1$ ), as in Figure 15.

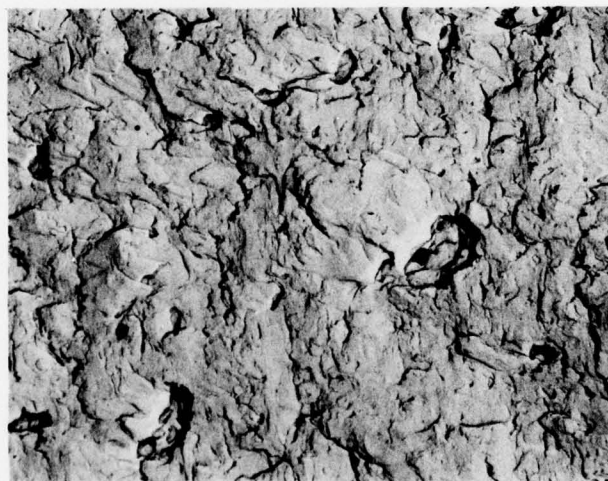
FIGURE 13: Electron micrograph of fatigue fracture face of AMVD HY130, E12018 weldment (9000x)

Fatigue fractures produced in all four series were also evaluated using electron fractography. There was no distinct difference in the fracture appearance of parent material before and after stress relief heat treatment. A typical area of fracture is shown in Figure 12. The fatigue striation indications are not pronounced for this  $R = -1$  specimen. Fatigue fractures in the weldments (Series 3) were not as flat. (Figure 13). However, indications of striations were, again, not very pronounced.

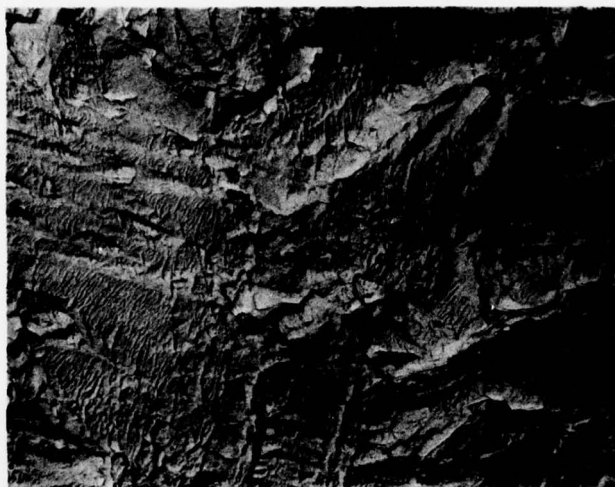
FIGURE 14: Electron micrograph of fatigue fracture in heat affected zone of HY130, E12018 weldment (at  $R = 0$ ) (9000x)

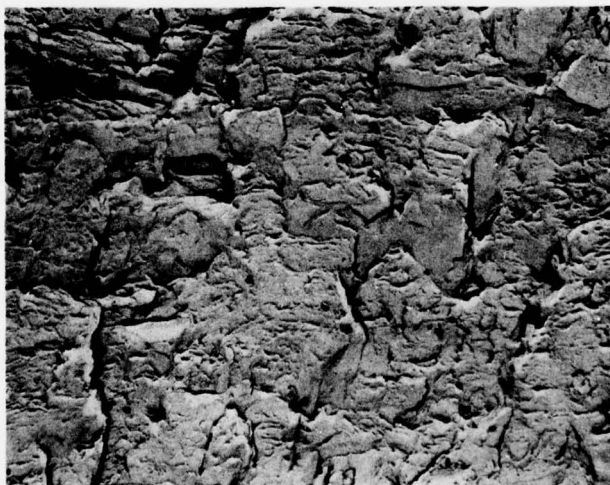
FIGURE 15: Electron micrograph of fatigue fracture in heat affected zone of HY130, E12018 weldment (at  $R = -1$ ) (9000x)

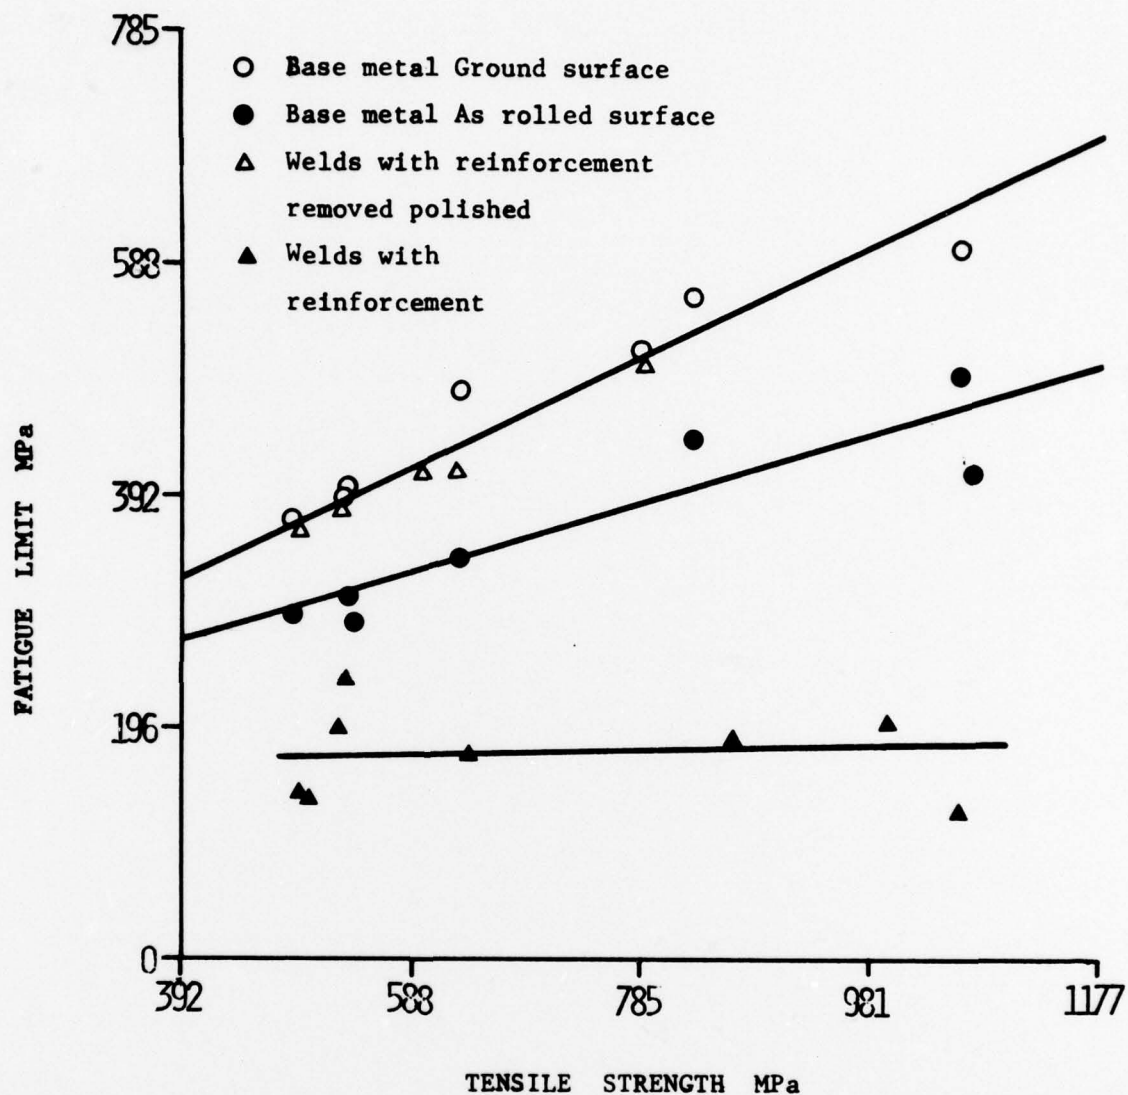
FIGURE 16: Graph showing range of fatigue properties with strength of high strength steels (from Takahashi et al<sup>14</sup>)

The foregoing results indicate that the fatigue properties of the welded HY130 steel are similar to those of other high strength steels.<sup>13</sup> As Figure 16 shows, other high strength construction steels with tensile strengths of 980 MPa (142 Ksi) also have fatigue strengths of approximately 550 MPa (80 Ksi) when ground and polished. Similarly, for other surface conditions, the HY130 steel has fatigue properties which compare to other high strength steels.
